# White Paper Report

Frelinghuysen Morris House & Studio  
Sustaining Cultural Humanities Collections:  
Planning for Sustainable Environmental Conditions to Preserve Collections  
Grant Number PF-50094-10  
Period: 3/01/2010 to 12/31/2011

## **White Paper**

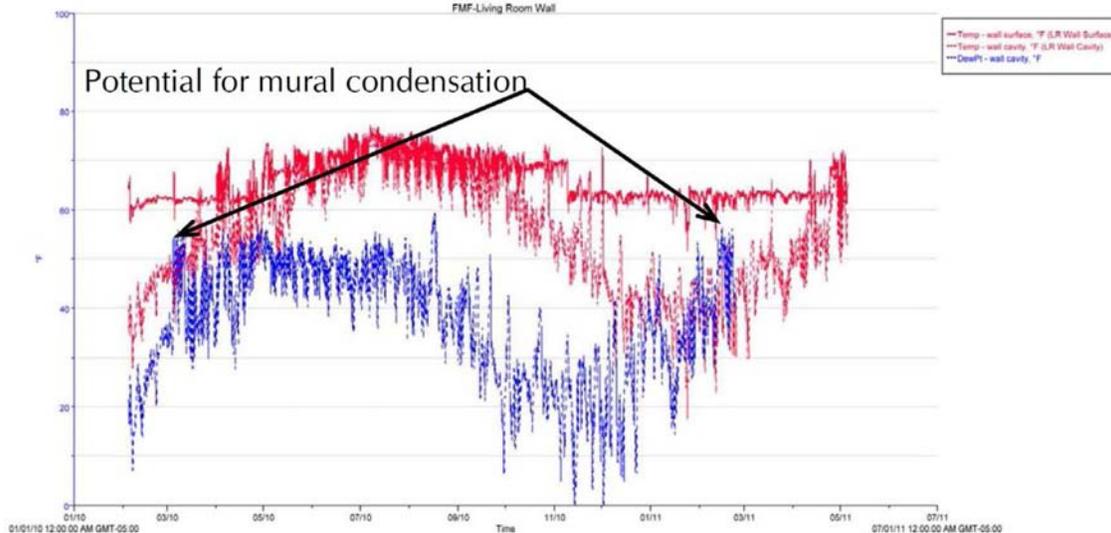
The data trend plot below shows:

- Interior (room-side) surface temperature of the wall;
- Cavity air temperature;
- Cavity air dew point temperature.

If the temperature of the glass fragment in the wall falls below the dew point temperature of the cavity, there is risk of condensation on the painted surface. However, the surface temperature of the glass fragment cannot not be measured directly because attachment of a sensor to the glass will damage the glass; therefore, the temperature of the glass fragment must be estimated from the wall surface temperature. A conservative estimate would be that the glass temperature is affected slightly by cavity temperature and therefore glass temperature is biased toward cavity temperature by several degrees warmer or cooler than the wall surface temperature.

The trend plot shows that there was a potential for condensation in March of both 2010 and 2011: this would occur during rising exterior dew point temperature from spring rains and depressed temperature of the north-facing wall after winter; it is aggravated somewhat by the intentional set-back of room temperature that is an effective part of winter relative humidity management for the collections.

The possible condensation of cavity moisture on the backside of the painted glass fragments in the wall mural is a complex phenomenon, but the measurements suggest that the occurrence is credible, even if the *WUFI*® simulation does not. Two key conditions, wall surface temperature, and cavity moisture, might be managed to reduce the possibility of condensation on the glass.

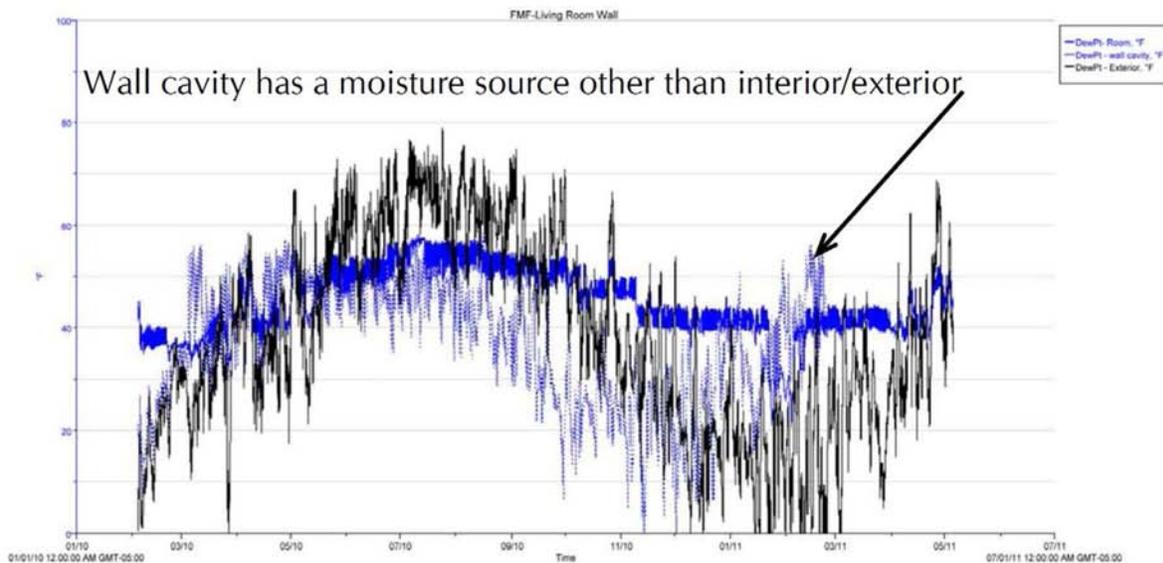
A simulation of the hygrothermal response of the living room mural wall was run using WUFI® (Wärme und Feuchte Instationär) software (<http://www.wufi-pro.com/>). The interior air conditions were set as sinusoidal over 12 months with temperature at 67°F  $\pm$ 2.5°F and the relative humidity at 42%RH  $\pm$ 5.5%RH, which approximated the seasonal set back. Exterior conditions were run using climate data from Albany, NY, the closest data source. The WUFI® simulation did not indicate the risk of condensation on the cavity face of the interior plaster/glass.

Comparison of the collected monitoring data and the WUFI® simulation suggest that there might be a source of moisture in the wall cavity; this would explain the higher dew point temperature in the monitoring data. The trend plot below indicates that cavity dew point temperature generally trends lower than exterior dew point in summer and higher than the exterior dew point in winter. In March, the cavity dew point temperature increase is independent of both interior and exterior dew point temperatures. This suggests that the building materials may be releasing stored moisture as the building warms in spring.
